In-Service Performance Evaluation (ISPE) for G4 (1S) Type of Strong-Post W-Beam Guardrail System and Cable Median Barrier: Volume II

Final Report

Prepared by:
Lehman Center for Transportation Research
Florida International University

Prepared for:
Research Center
Florida Department of Transportation

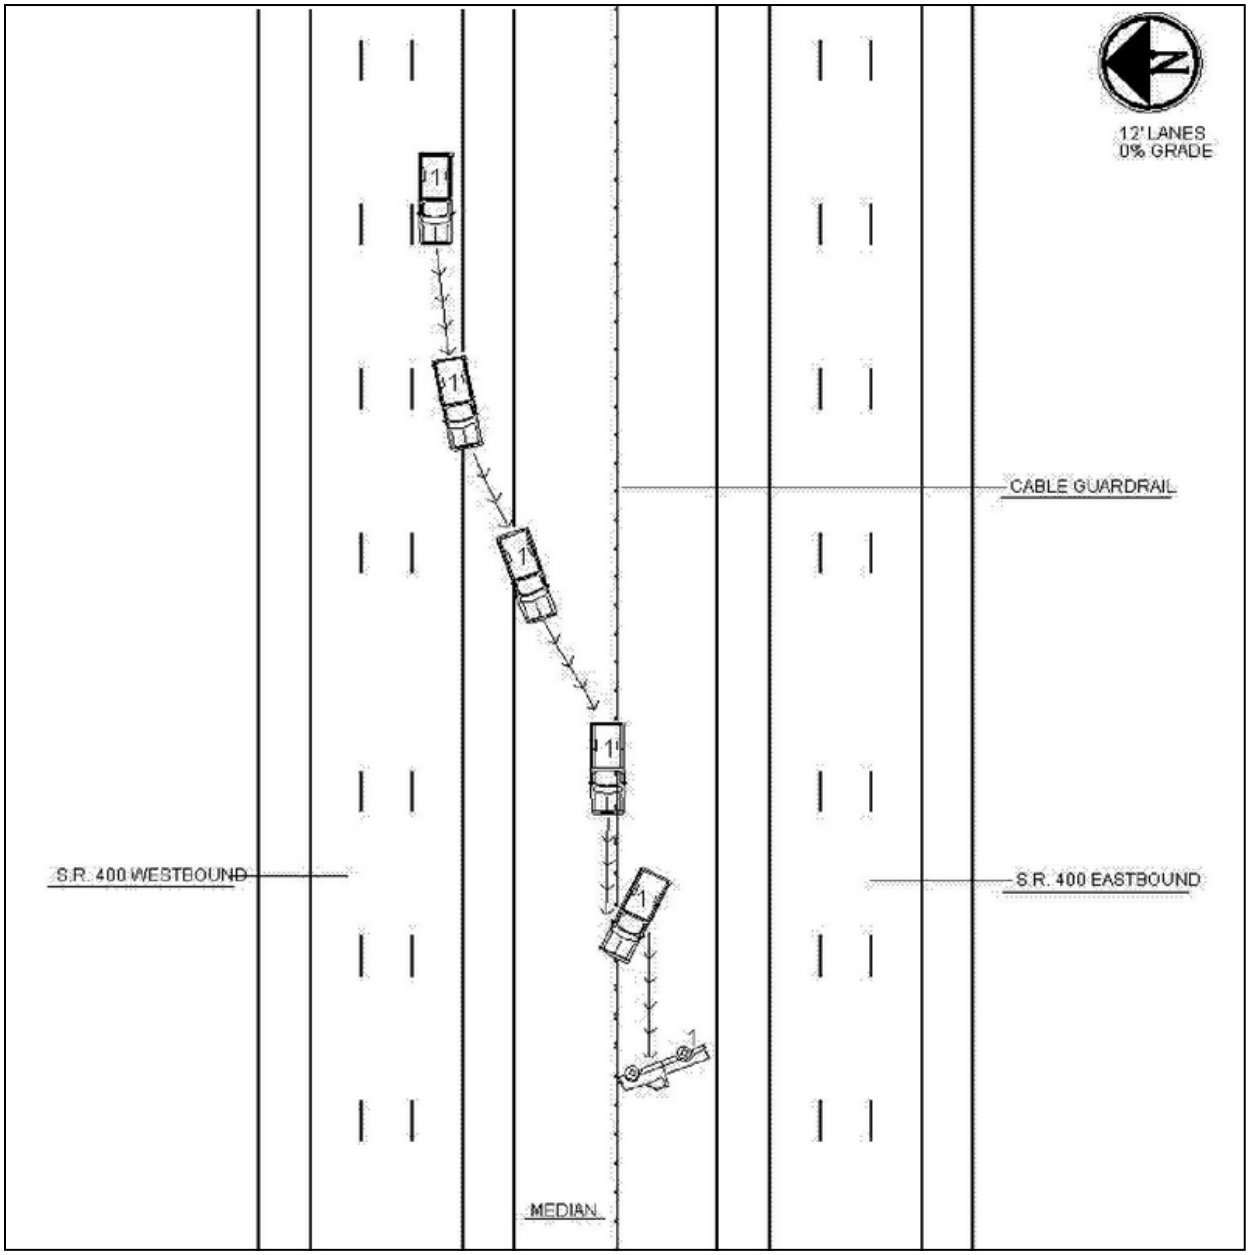
V1 was traveling west on S.R. 400. The driver of V1 stated that he fell asleep at the wheel. V1 left the road and entered the median. V1 struck the cable guardrail and overturned onto its left side. V1 came to final rest on its left side facing in an westerly direction in the median of S.R. 400.

Figure 3-1: Example of a Barrier Crossover Over-ride Crash (Crash # 776721690)

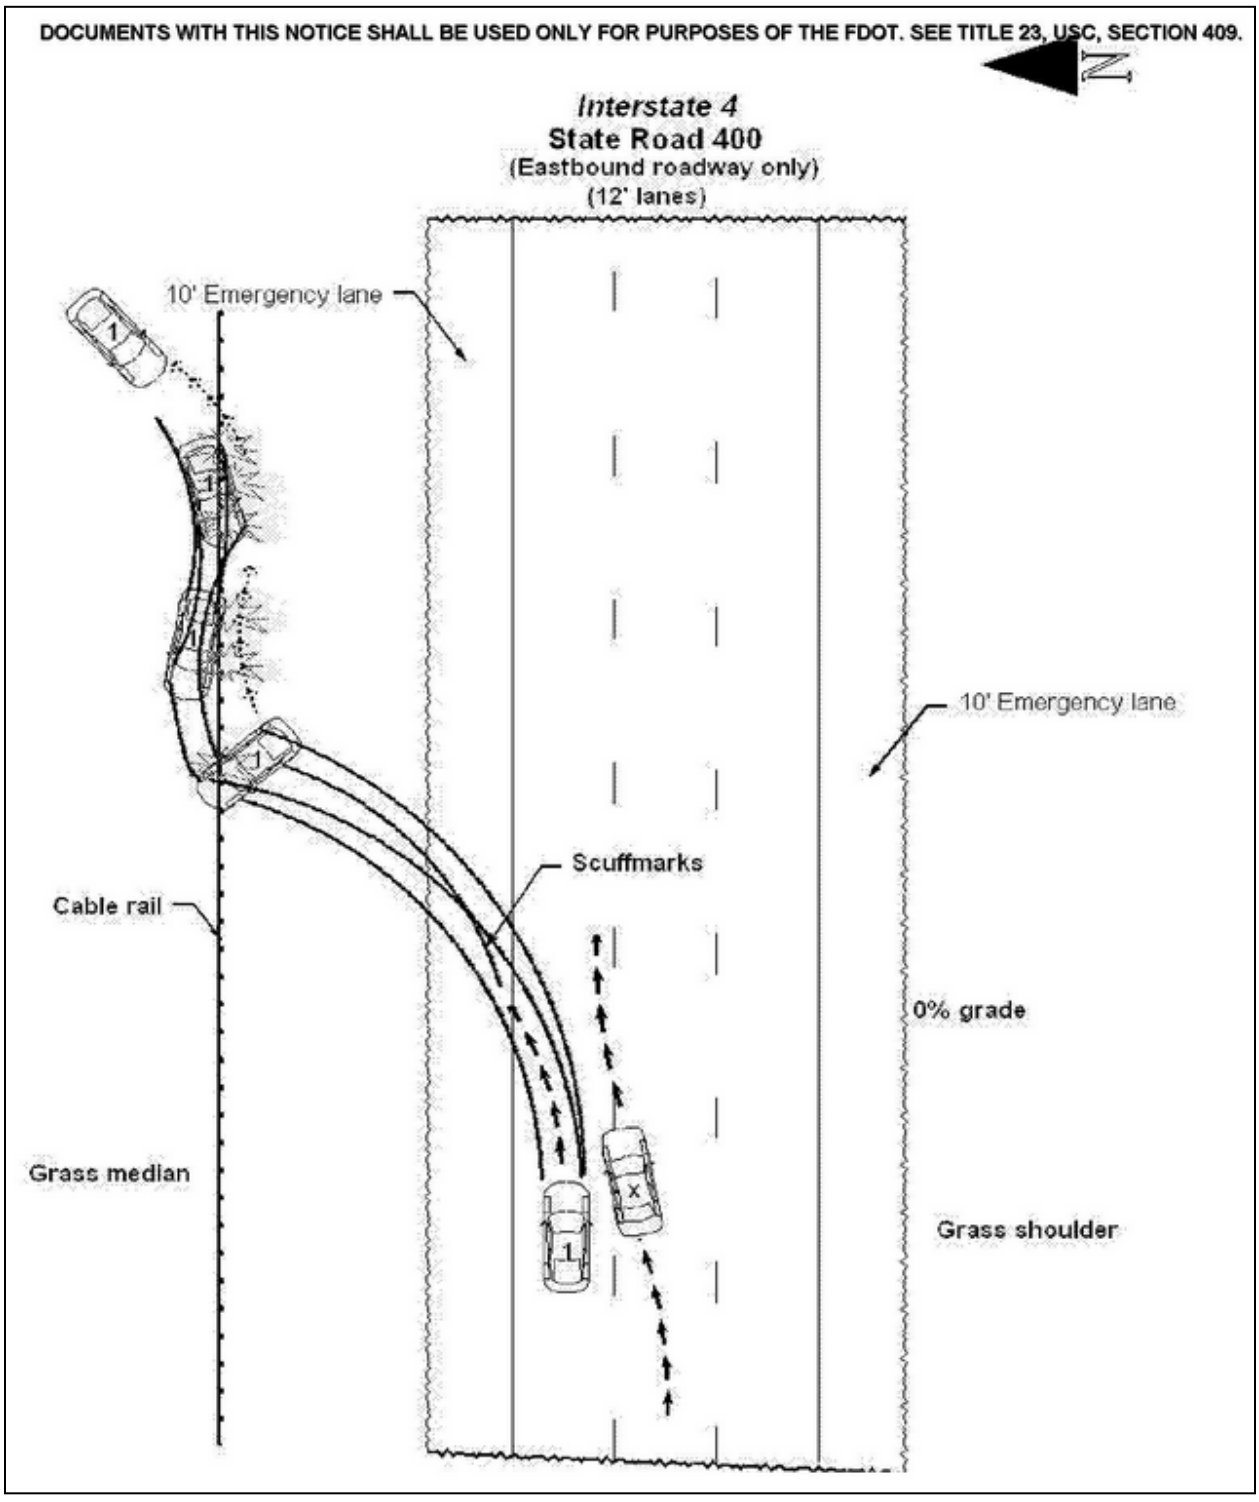
V-1 was eastbound on State Road 400 in the inside lane. A vehicle that was eastbound on State Road 400 in the middle lane, alongside V-1, changed lanes toward V-1. D-1 swerved to her left and slid off the roadway into the grass median. V-1 rotated in a counterclockwise manner, sliding into the cable rail in the median. The left side of V-1 struck a cable support. V-1 traveled partially through the cable rail, continuing to rotated counterclockwise. V-1 slid down the cable rail, underneath the cables, making contact with the rail supports with the rear and left side of V-1, before rotating out, traveling backward, into the median, coming to rest. V-1 was a non-contact vehicle that left the scene.

Figure 3-2: Example of a Barrier Crossover Under-ride Crash (Crash # 776553840)

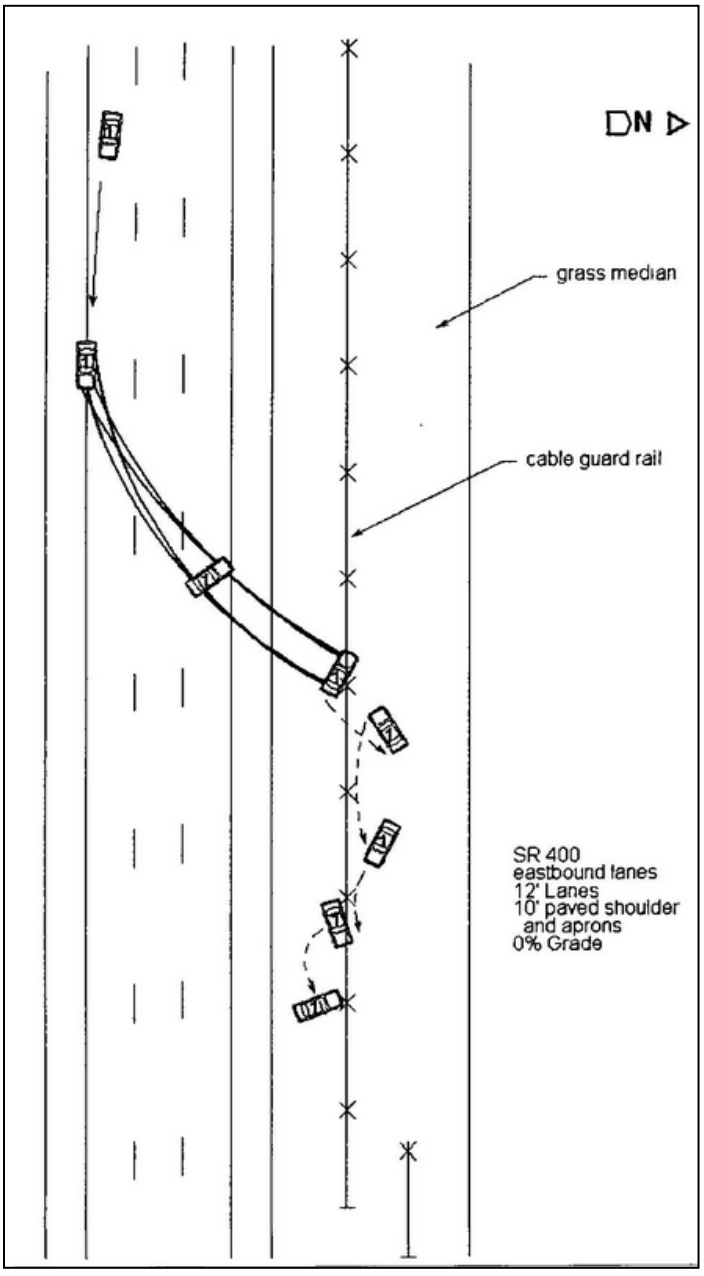
V-1 was eastbound on SR 400 in the outside lane. V-1's right side tires entered the south edge of the roadway. D-1 over corrected to the left causing V-1 to travel across the eastbound lanes rotating counterclockwise. V-1 entered the median striking the cable guard rail with V-1's right side. V-1 traveled through the guard rail. V-1's front rotated to face eastbound. V-1 traveled eastbound toward the guard rail. V-1 traveled through the guard rail a second time rotating counterclockwise coming to final rest on the south side of the guard rail facing northwest. D-1 stated that she was originally in the center lane and was operating her GPS. When she looked up again she was close to a truck. She then traveled into the outside lane and onto the south edge of the roadway and lost control of her vehicle.

Code 24 Contributing Causes Driver distractions V-1: Driver operating GPS system.

Damage to the cable guard rail west of the 40.3 mile marker. Approximately 125 feet damaged.

Figure 3-3: Example of a Barrier Crossover Penetration Crash (Crash # 771491090)

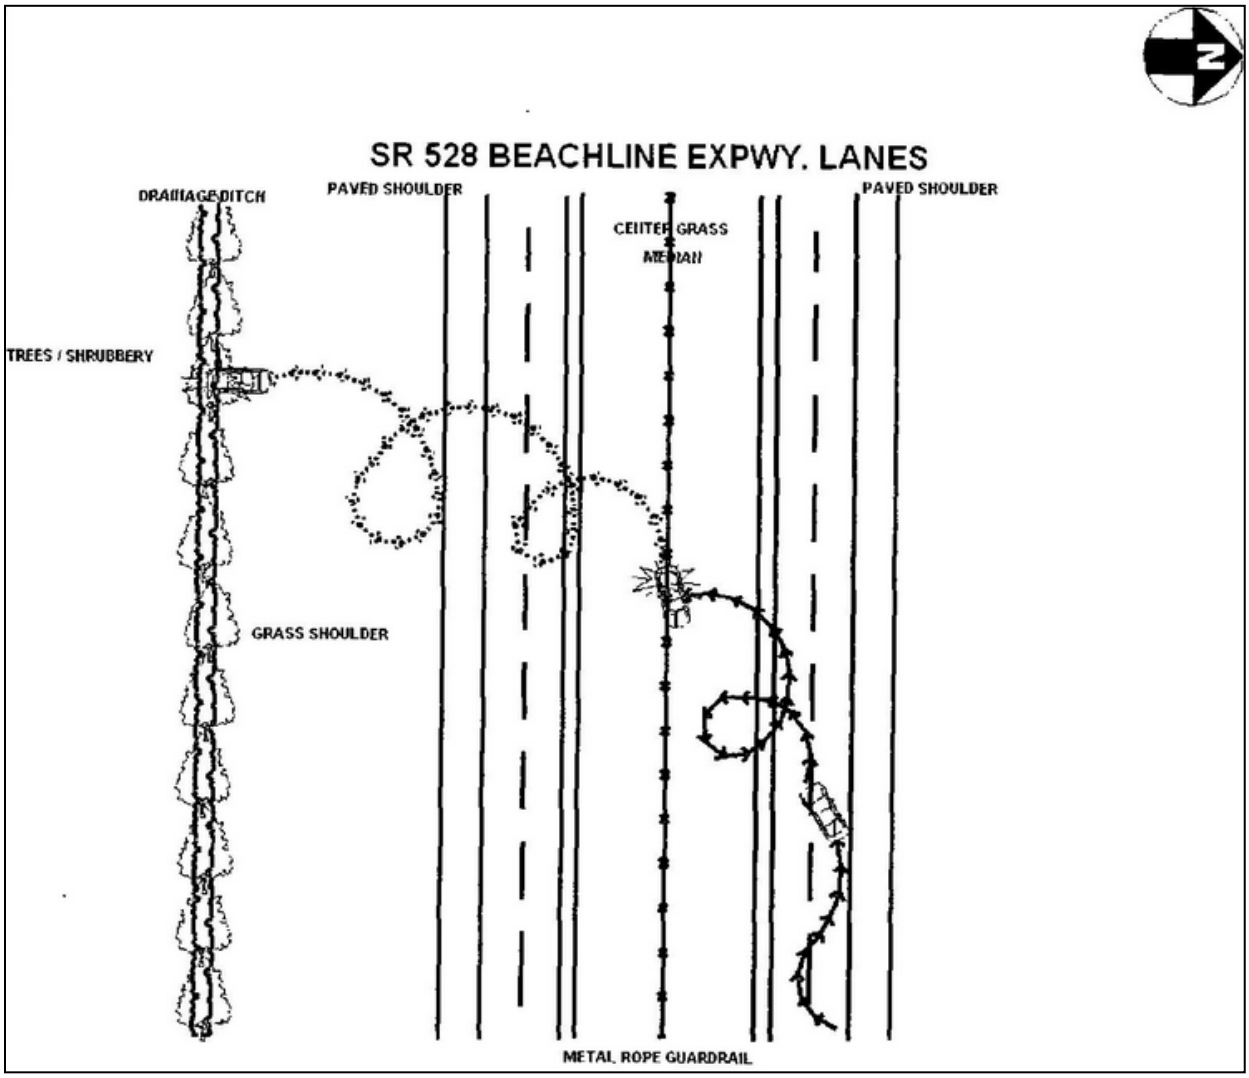
V1 WAS TRAVELING WEST ON SR 528 IN THE RIGHT LANE NEAR THE 22 MILE MARKER. V1 DRIVER STATED THAT SHE ATTEMPTED TO PASS A DUMP TRUCK, SHE WENT FROM THE RIGHT TO THE LEFT LANE, THEN TRIED TO GO BACK TO THE RIGHT LANE, RAN UPON THE UNEVEN PAVEMENT, LOST CONTROL OF HER STEERING HIT HER BRAKES, WENT INTO A COUNTER CLOCKWISE SPIN, RAN BACK ACROSS THE LEFT LANE INTO THE CENTER GRASS MEDIAN STRIKING THE METAL ROPE GUARDRAIL WITH THE LEFT SIDE OF HER VEHICLE, OVERTURNED HER VEHICLE CROSSING THE GUARDRAIL, CROSSING THE EASTBOUND LANES AND PAVED SHOULDER ONTO THE GRASS SHOULDER WHERE IT CAME TO FINAL REST CRASHING INTO SOME SMALL TREES, AND SHRUBBERIES. * ROAD CONDITION LEFT LANE HAD BEEN NEWLY PAVED / UNEVEN LANES.

Figure 3-4: Example of a Median Crossover Crash (Crash # 771887130)

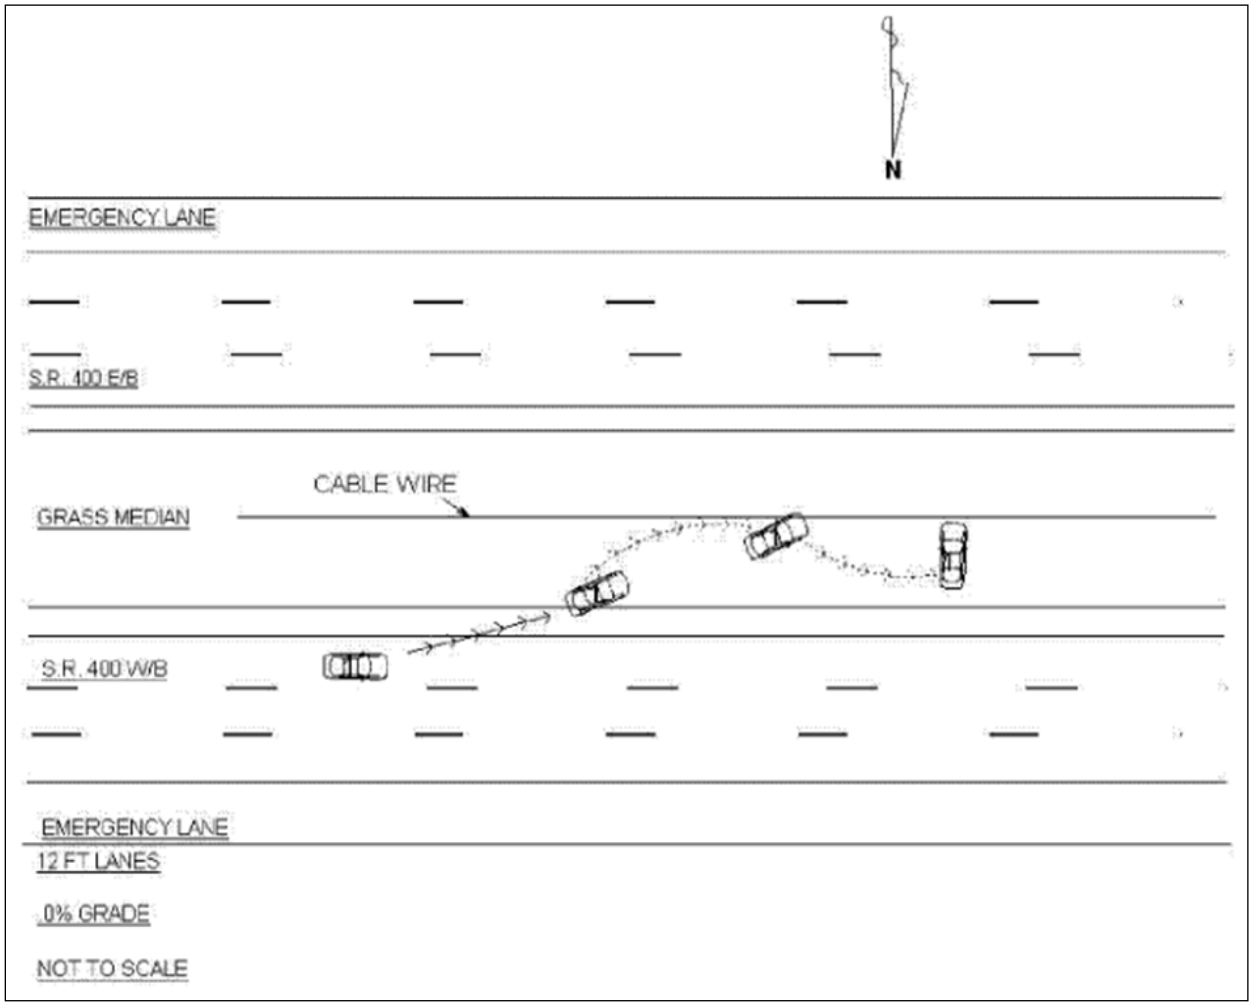
V1 was westbound on SR-400 in the inside lane. For an unknown reason, the driver of V1 lost control of the vehicle. V1 continued in a westerly direction onto the median. V1 then started to rotate clockwise and struck a cable wire with it's left front. V1 came to final rest at this time without further incident. V1 came to final rest facing south.Contributing Causes-Careless Driving-V1 failed to maintain control of vehicle.Cable wire stopped the vehicle movement.

Figure 3-5: Example of a Non-Crossover Redirected Crash (Crash # 773972380)

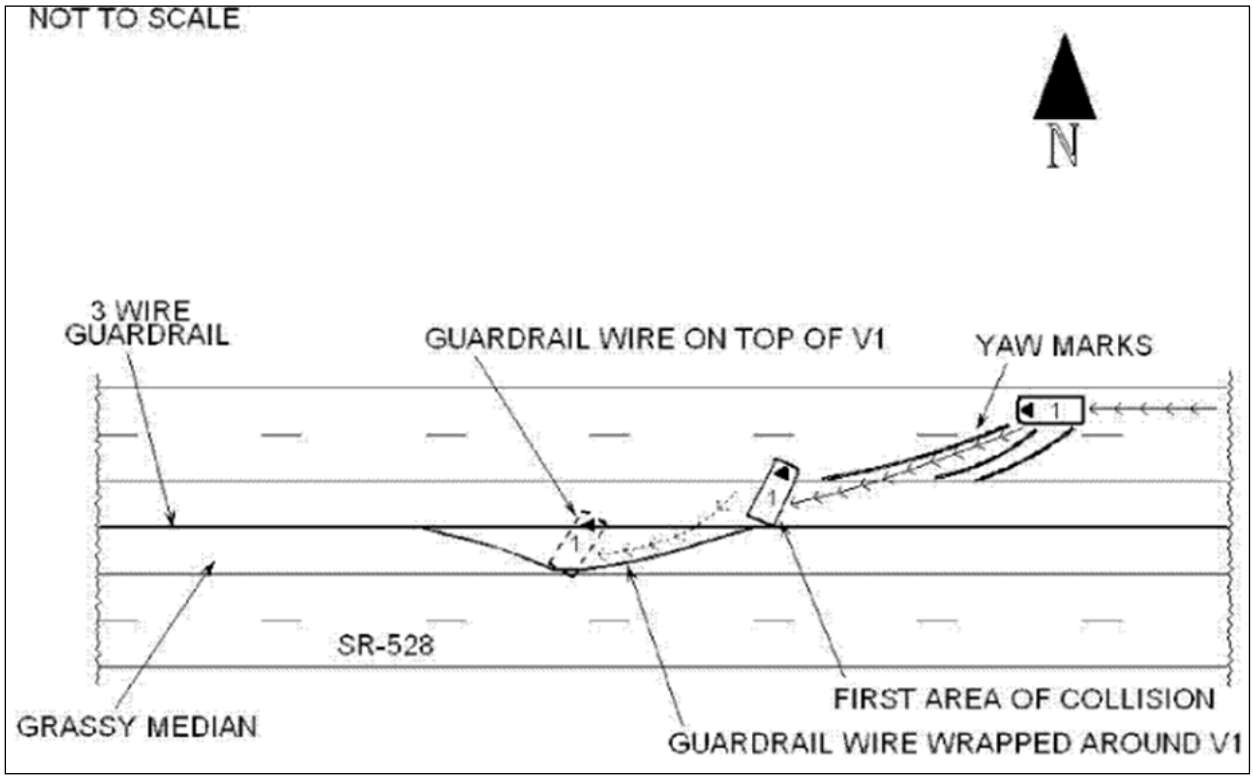
V1 WAS TRAVELING WESTBOUND ON SR-528 IN THE OUTSIDE LANE. THE TIRE TREAD ON V1'S LEFT REAR TIRE SEPARATED CAUSING D1 TO LOSE CONTROL OF THE VEHICLE. V1 ROTATED CLOCKWISE AS V1 SLID ACROSS THE WESTBOUND TRAVEL LANES AND INTO THE MEDIAN. THE RIGHT REAR OF V1 THEN COLLIDED WITH THE WIRE GUARDRAIL. V1 CONTINUED TO SLIDE TO THE SOUTHWEST AS THE WIRE GUARDRAIL SLOWED V1 TO A STOP. V1 CAME TO FINAL REST FACING NORTHEAST IN THE MEDIAN AND WAS ENTANGLED IN THE WIRE GUARDRAIL. NOTE: 2 OF THE 3 GUARDRAIL WIRES TRAVELED OVER THE ROOF OF V1 CAUSING ADDITIONAL DAMAGE.

Figure 3-6: Example of a Non-Crossover Contained Crash (Crash # 776779740)
